## AS BUILT DRAWING

Wealden District Council  
 Hailsham Head Quarters  
 Refurbishments and Alterations

Proposed Ground Floor Plan  
 Council Offices Building  
 Reflected Ceiling Plan

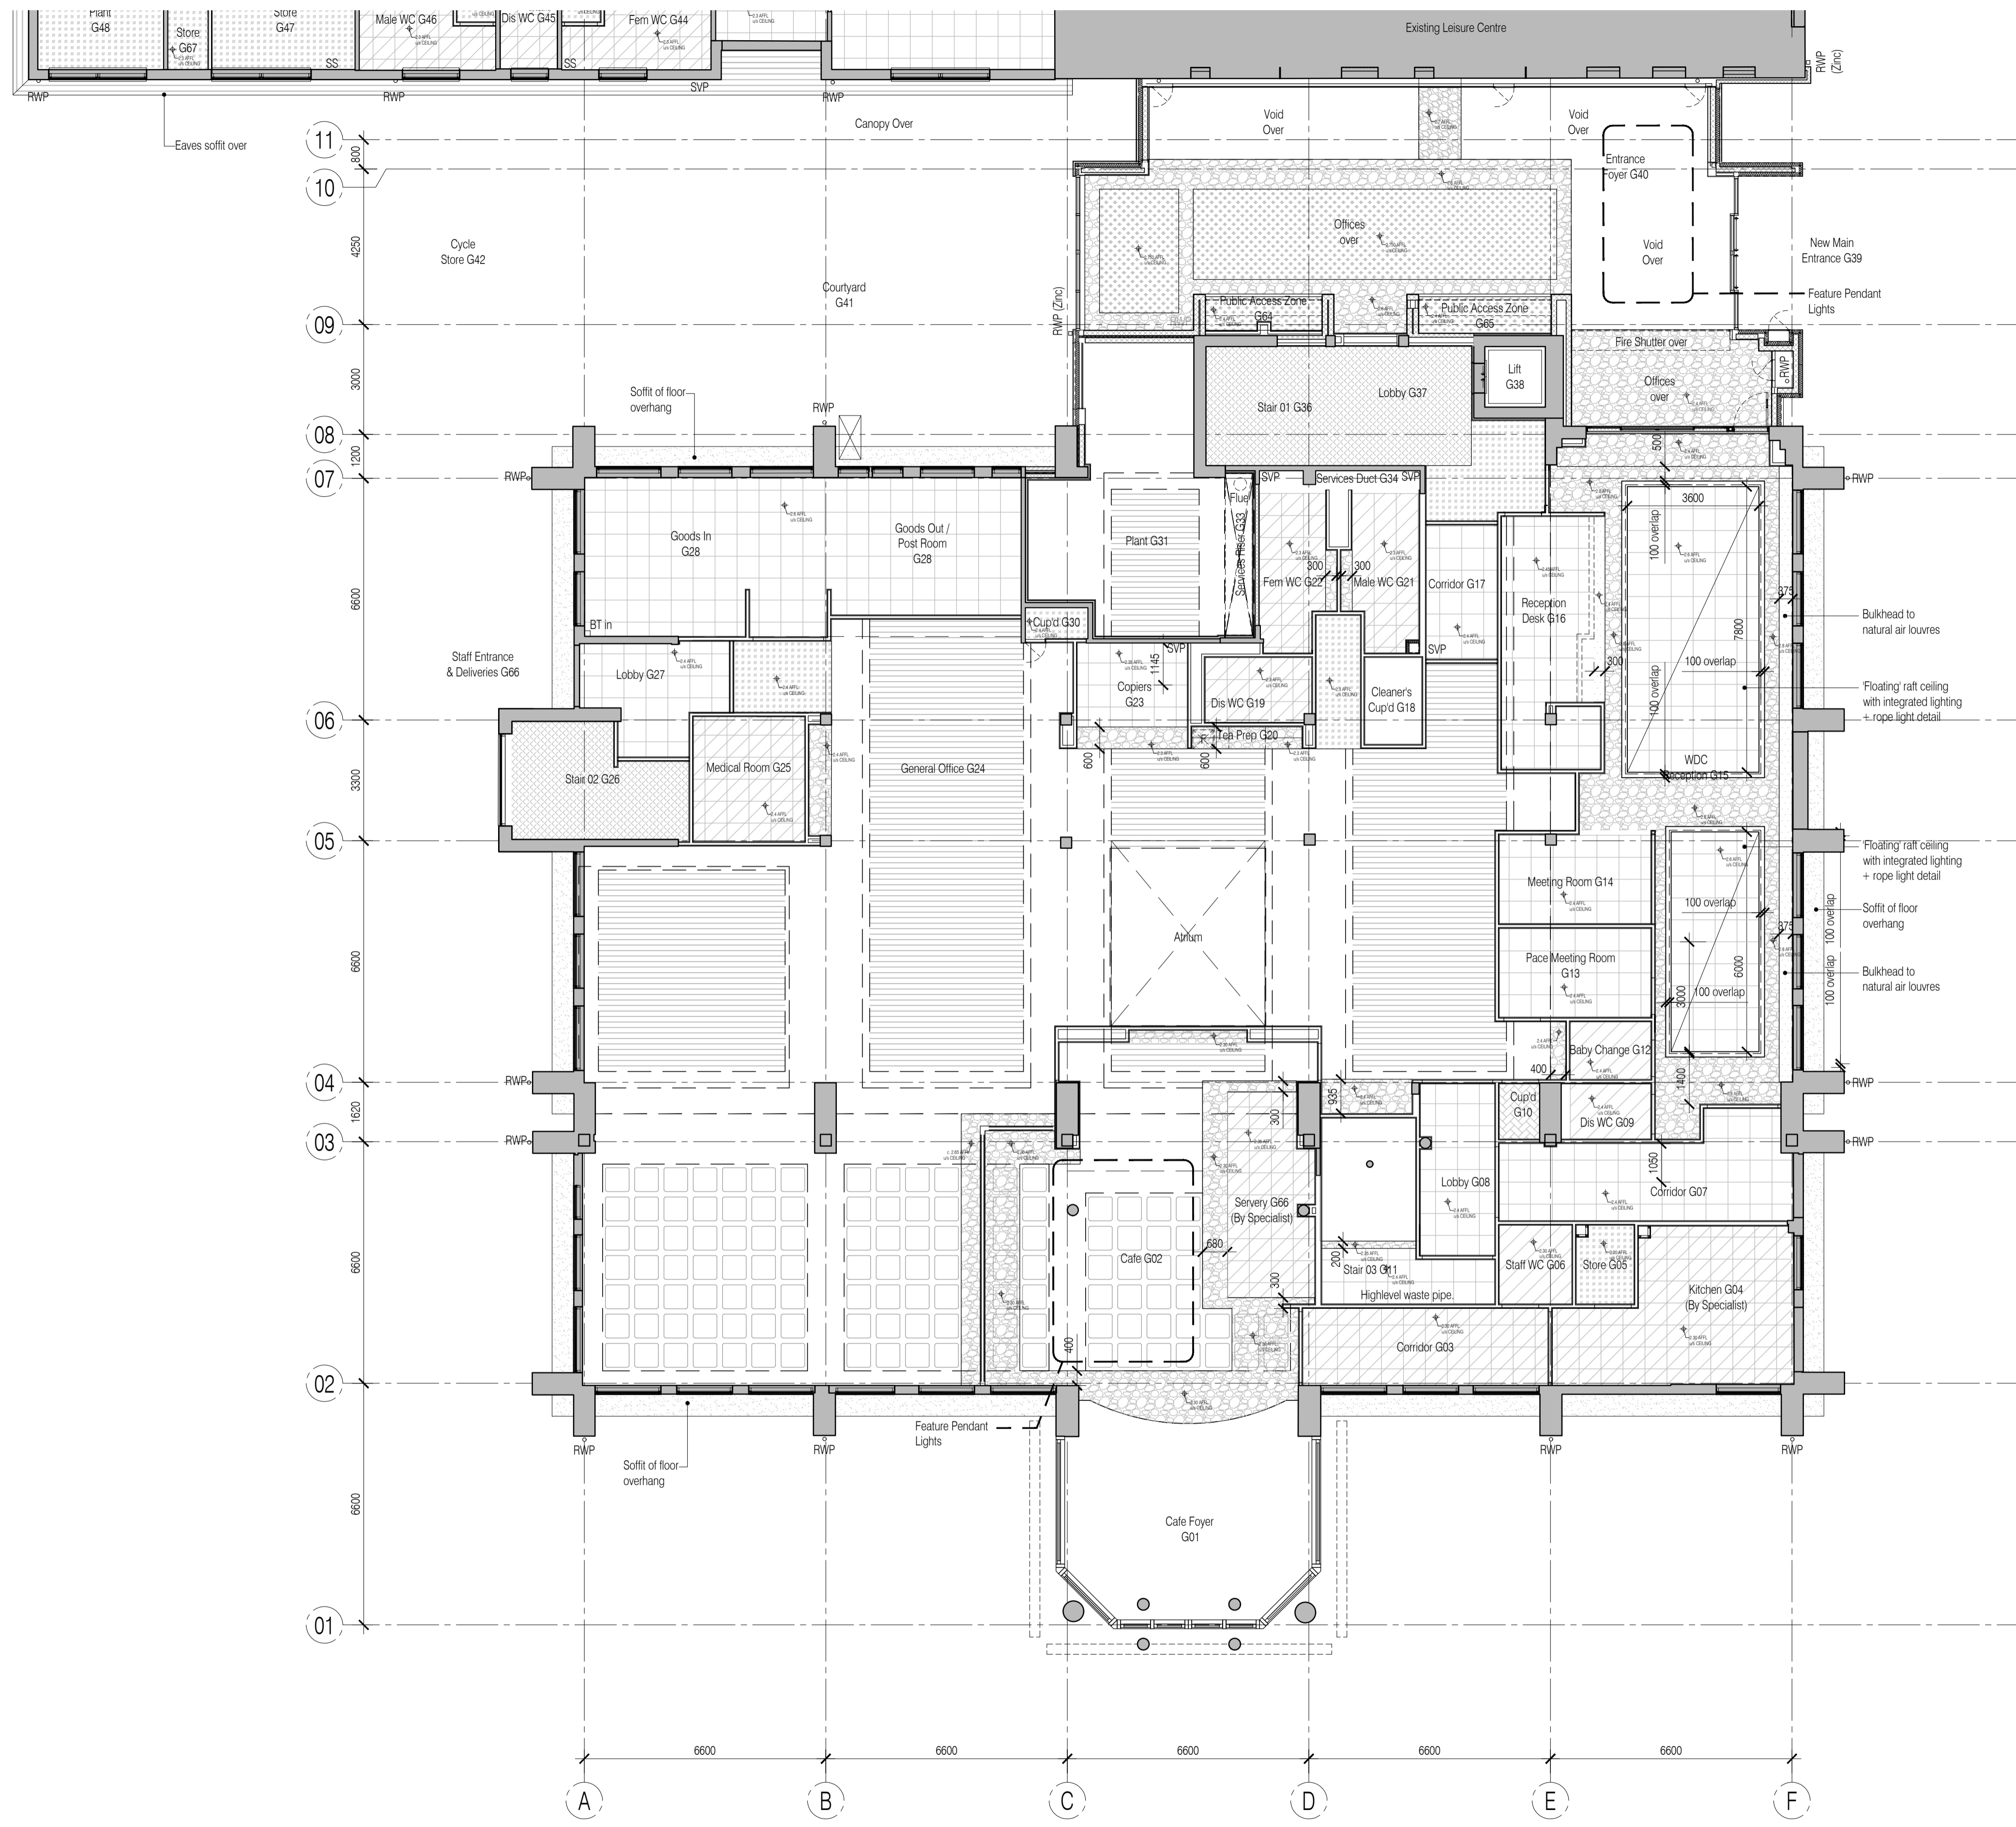
- Reflected Ceiling Plan Legend**  
 All colours to be confirmed.  
 All unhatched areas are exposed concrete soffits to be made good and painted.
- Plasterboard bulkhead with downlights

- Suspended Armstrong Diploma E24 suspended 600x600 grid - meeting rooms + general areas
  - Suspended Armstrong BioGuard Acoustic E24 suspended 600x600 grid - hygienic areas

- Plasterboard ceiling
  - Rockfon Alaska D Acoustic Suspended 600 x 600 grid - High sound absorption
  - Existing ceiling made good and painted white
  - Underside of concrete slab made good and painted white

- Phase change plasterboard bulkhead
  - Exposed waffle slab made good and painted. Colour TBC.
  - Exposed beam and pot floor made good and painted. Colour TBC.

- Exposed pre-cast slab made good and painted. Colour TBC.
  - Phased change F.E.S. board ceiling material (for thermal mass)
  - 1hr Fire Ceiling: 2x layers of 12.5mm Fireline plasterboard in accordance with Manufacturer's design and instructions
